**Flood Control Project Maintenance
Levee Inspections**

Fall 2016 Levee Maintenance Deficiency Summary Report

Sacramento River Basin

Reclamation District No. 0900 West Sacramento

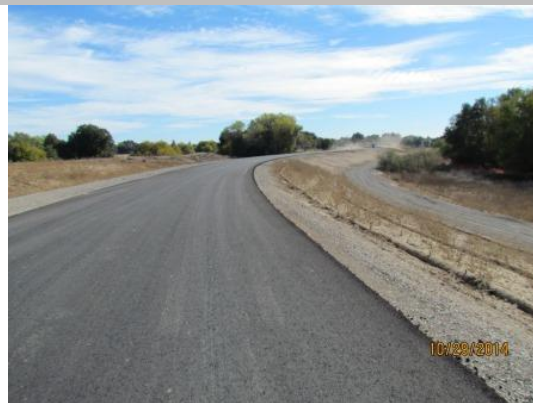
Photo 1 of 1 : FA_2016_RD0900_230_1_20160823_00001.jpg

View of the new setback levee looking downstream during fall 2014 inspection.

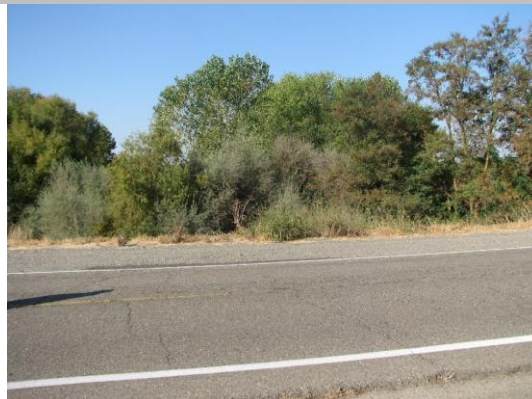
Photo 1 of 2 : UCIP_FA_2016_37665_68376.jpg

LM Start	2.15	Rating **	M	Issue No.	971
LM End	2.15	Issue Type +	En	Location *	CR
Category	Supplemental			GPS Latitude/Longitude	
				Start	End
Item	DWR UCIP Field Study			38.556994 °	38.556994 °
				-121.516843 °	-121.516843 °
DWR ID					
Comment Code					
Inspector Comment					
FS_ID:37665 DS_ID:17772 EP_NO: N/A Repair Type: Non-Urgent Crossing Status: Found UCIP Comments: Dense vegetation limits the inspector's visibility to identify signs of pipe failure (leaks) along the slope. Recommend removing vegetation along pipe alignment to conduct proper inspection of structure and appurtenances. FIELD_STRUCT_DESC: 42-inch pipeline through the levee 21.5 feet below the crown. Slide gate in concrete riser on the waterward slope. Flap gate on the waterward end. FS Date: 10/6/2009

View of levee crown at crossing.

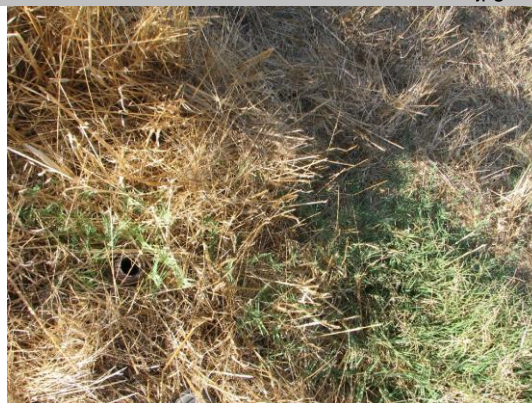
Photo 2 of 2 : UCIP_FA_2016_37665_68375.jpg

Air vent visible through dense vegetation.

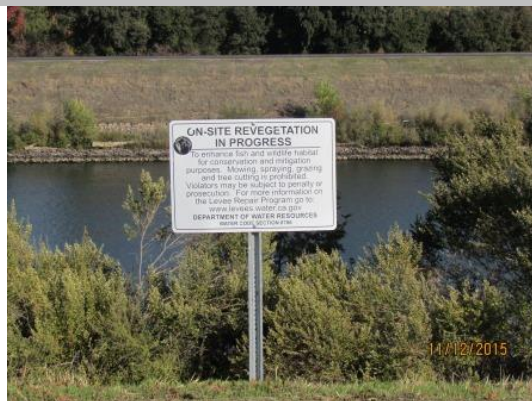
Photo 1 of 1 : FA_2016_RD0900_230_17_20160823_00011.jpg

View of the DWR environmental mitigation site.

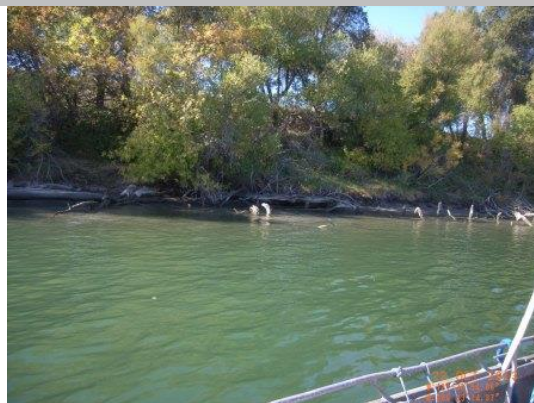
Photo 1 of 1 : FA_2016_RD0900_230_10_20160823_00008.jpg

LM Start	2.35	Rating **	M	Issue No.	10							
LM End	2.47	Issue Type +	Ma	Location *	WS							
Category	Supplemental		GPS Latitude/Longitude									
			Start	End								
Item	2015 USACE Erosion Survey, DRAFT		38.554277 °	38.552504 °								
			-121.515263 °	-121.514752 °								
DWR ID	DWR_RD0900_01_s_2016_10											
Comment Code												
Inspector Comment												
2007 - Have good berm width with minor toe erosion. Close to the levee toe protection, but levee slope is steep. 2011 - New large erosion pocket. 2012 - Minor new erosion at the toe. 2015: No observed changes. [2015 Site ID: SAC_56-7_R]

USACE 2013 Photo #1

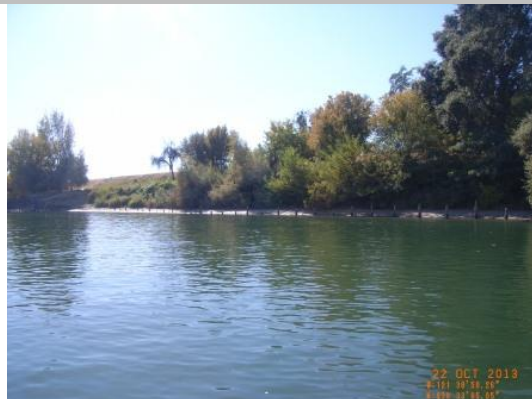
Photo 1 of 1 : FA_2016_RD0900_230_9_20160823_00007.jpg

LM Start	2.55	Rating **	M	Issue No.	9
LM End	2.64	Issue Type +	Ma	Location *	WS
Category	Supplemental			GPS Latitude/Longitude	
				Start	End
Item	2015 USACE Erosion Survey, DRAFT			38.551319 °	38.550090 °
				-121.514423 °	-121.513983 °
DWR ID	DWR_RD0900_01_s_2016_9				
Comment Code					
Inspector Comment					
1997 - Low berm is contributing to erosion. Old timber pile dikes above water parallel to bank. The upstream mitigation low berm causes a flow separation at the site. 1999 - Some new localized erosion with less thank one foot of bank retreat. 2000 - Some new erosion at the upstream end. Fat toe deposits at toe. 2003 - Some new erosion upstream, but have a wide berm. 2011 - Minor new erosion at toe. 2015: No observed changes. [2015 Site ID: SAC 56-5 R]

USACE 2013 Photo #1

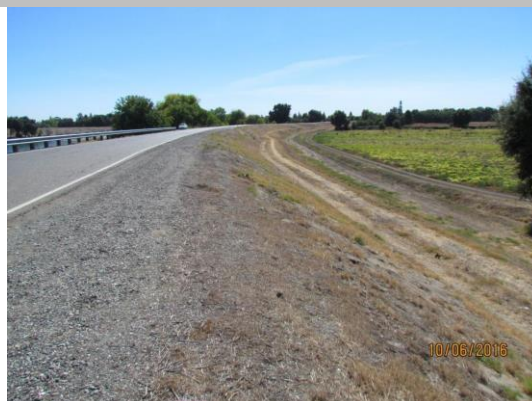
Photo 1 of 1 : FA_2016_RD0900_230_61_20161010_00031.jpg

View of the landside of the levee looking downstream. Fall 2016

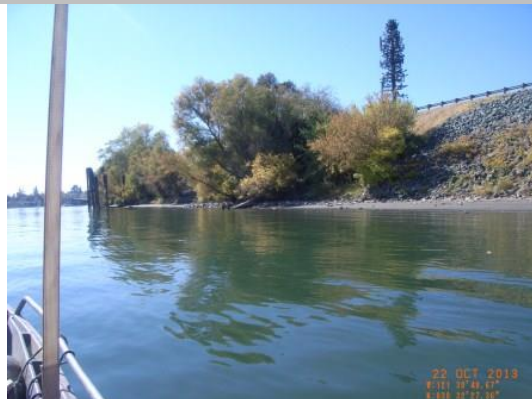
Photo 1 of 1 : FA_2016_RD0900_230_2_20160823_00002.jpg

USACE 2013 Photo #1

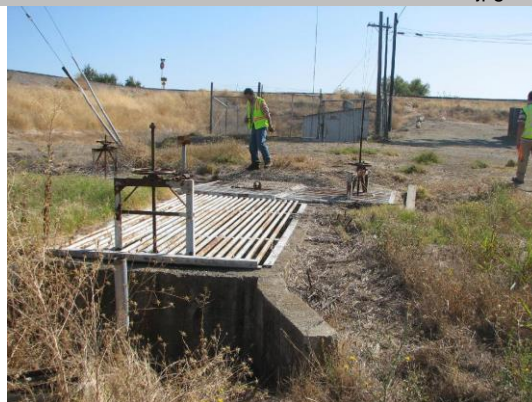
Photo 1 of 2 : UCIP_FA_2016_37668_68391.jpg

View of concrete structure located on landward side.

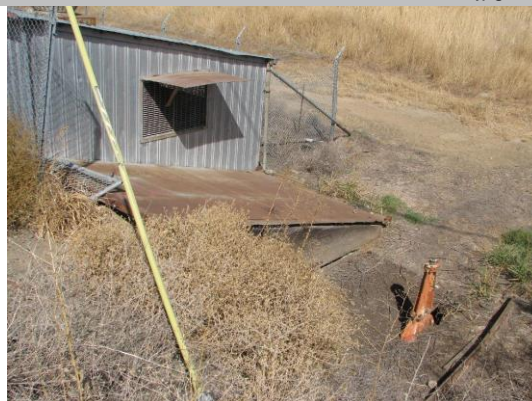
Photo 2 of 2 : UCIP_FA_2016_37668_68390.jpg

Pump house located on landward side.

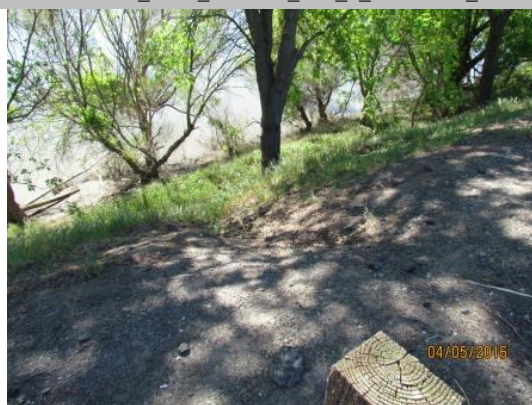
Photo 1 of 2 : FA_2016_RD0900_230_4_20160823_00003.jpg

Updated picture of the slope instability on the waterside of the levee looking downstream during spring 2016 inspection.

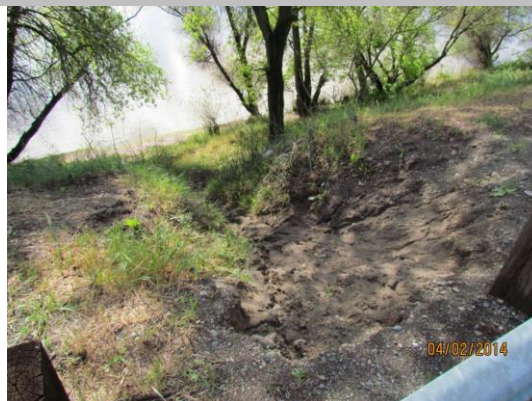
Photo 2 of 2 : FA_2016_RD0900_230_4_20160823_00004.jpg

A slope instability was found on the waterside slope of the levee looking downstream.

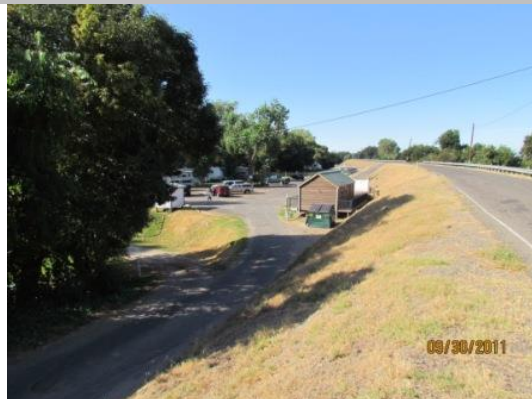
Photo 1 of 1 : FA_2016_RD0900_230_20_20160823_00012.jpg

View of Sherwood harbor's unpermitted properties on the waterside of the levee. The picture was taken from the crown looking upstream.

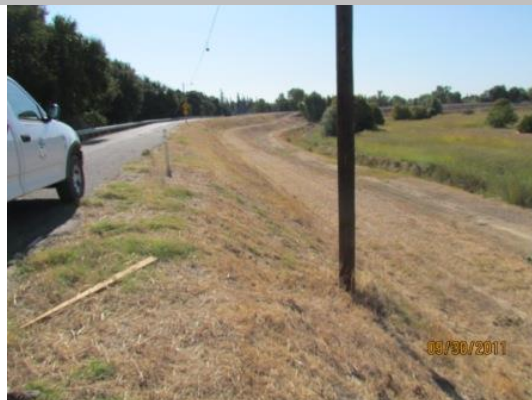
Photo 1 of 1 : FA_2016_RD0900_230_332_20160823_00021.jpg

View of the pole on the landside of the levee looking upstream.

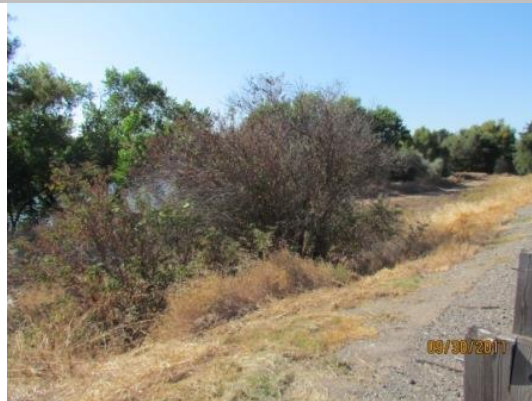
Photo 1 of 1 : FA_2016_RD0900_230_335_20160823_00022.jpg

View of elderberry bush on the waterside of the levee looking upstream.

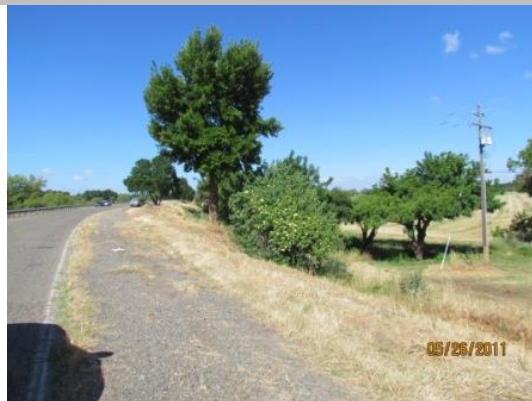
Photo 1 of 1 : FA_2016_RD0900_230_958_20160823_00024.jpg

LM Start	5.51	Rating **	M	Issue No.	958
LM End	5.51	Issue Type +	Ma	Location *	LS
Category	Earthen Levee			GPS Latitude/Longitude	
				Start	End
Item	Vegetation			38.518988°	38.518988°
				-121.527738°	-121.527738°
DWR ID	DWR_RD0900_01_s_2012_958				
Comment Code					
V4 : Elderberries are blocking visibility and flood fight capability.					
Inspector Comment					
Elderberries are partially blocking the visibility.

Elderberry on the landside of the levee. The picture was taken from the crown looking downstream.

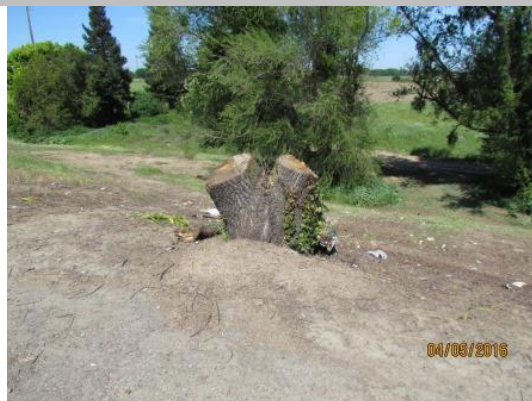
Photo 1 of 1 : FA_2016_RD0900_230_64_20160823_00018.jpg

View of a tree stump on the landside of the levee looking downstream.

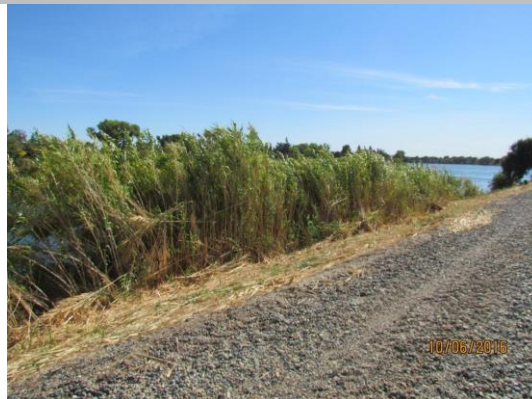
Photo 1 of 2 : FA_2016_RD0900_230_59_20161010_00033.jpg

Updated picture of the arundo on the waterside of the levee during fall 2016 inspection.

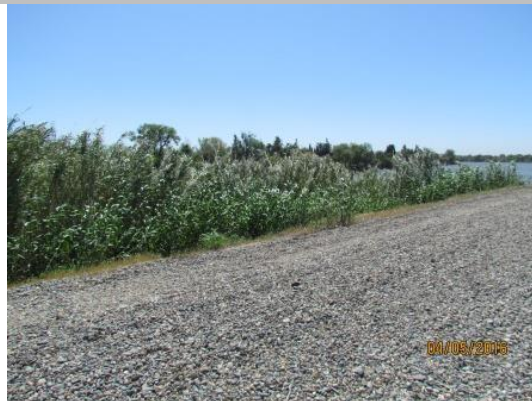
Photo 2 of 2 : FA_2016_RD0900_230_59_20160823_00015.jpg

Updated picture of the arundo on the waterside of the levee during spring 2016 inspection.

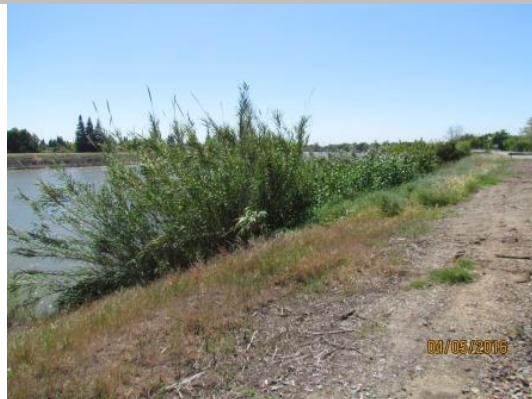
Photo 1 of 2 : FA_2016_RD0900_230_15_20160823_00009.jpg

Updated picture of the arundo on the waterside of the levee during spring 2016 inspection.

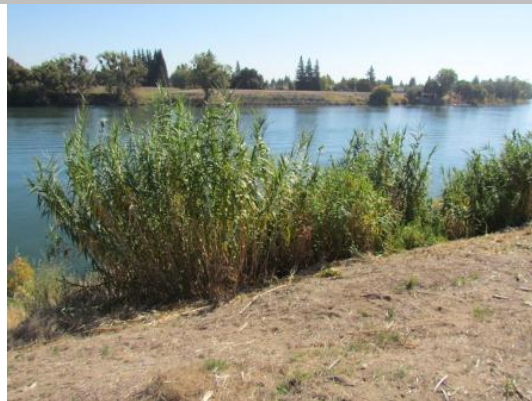
Photo 2 of 2 : FA_2016_RD0900_230_15_20160823_00010.jpg

View of arundo on the waterside of the levee looking downstream.

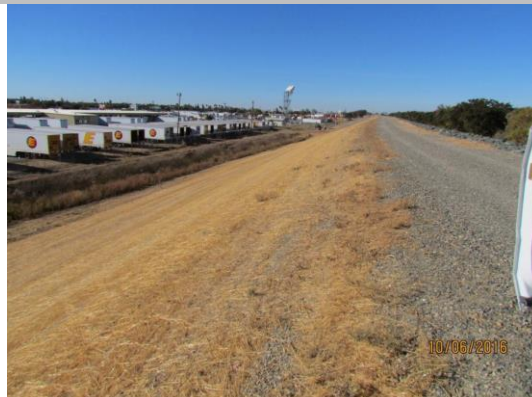
Photo 1 of 1 : FA_2016_RD0900_231_44_20161010_00044.jpg

View of the landside of the levee looking downstream. Fall 2016

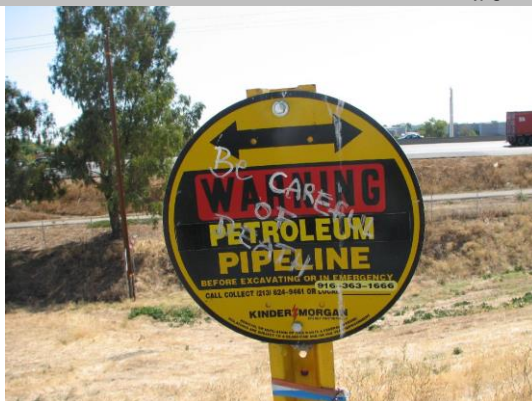
Photo 2 of 2 : UCIP_FA_2016_41825_72724.jpg

Marker of petroleum pipeline unable to confirm permit--there are 3 gas line in desk study records for gas line but none for Kinder Morgan.

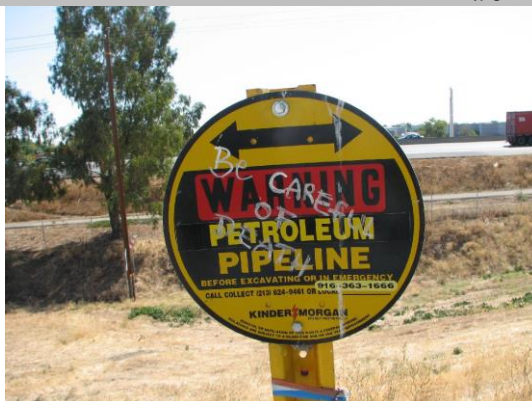
Photo 2 of 2 : UCIP_FA_2016_41826_72721.jpg

Marker of petroleum pipeline unable to confirm permit--there are 3 gas line in desk study records for gas line but none for Kinder Morgan.

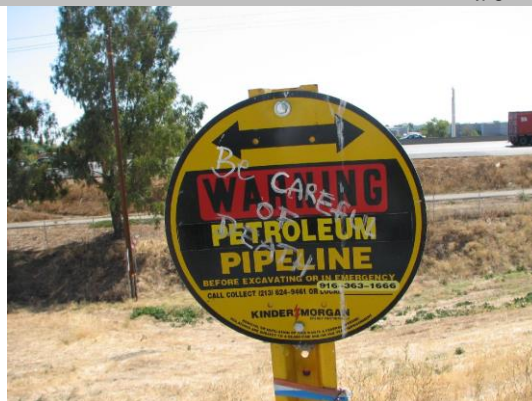
Photo 2 of 2 : UCIP_FA_2016_41824_72727.jpg

Marker of petroleum pipeline unable to confirm permit--there are 3 gas line in desk study records for gas line but none for Kinder Morgan.

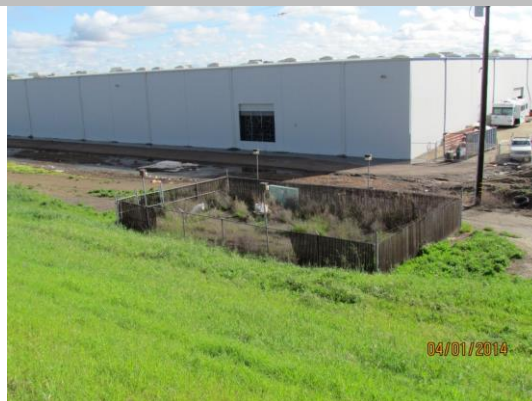
Photo 1 of 1 : FA_2016_RD0900_231_5_20160823_00001.jpg

View of the water well on the landside toe of the levee looking upstream.

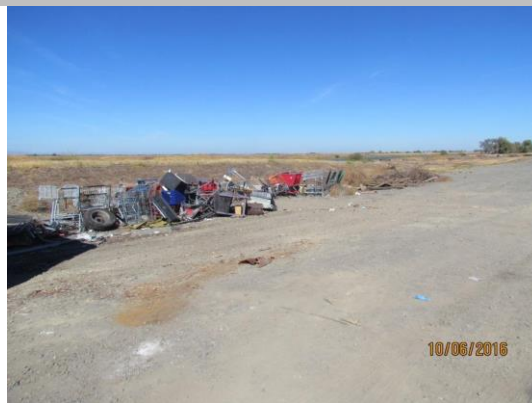
Photo 1 of 1 : FA_2016_RD0900_231_45_20161010_00046.jpg

View of debris on the landside shoulder of the levee looking upstream.
